# Non-destructive damage analysis in Kariye (Chora) Museum as a cultural heritage building

C. Çağlar Yalçiner<sup>a</sup>, Aydın Büyüksaraç<sup>b,\*</sup>, Yunus Can Kurban<sup>c</sup>

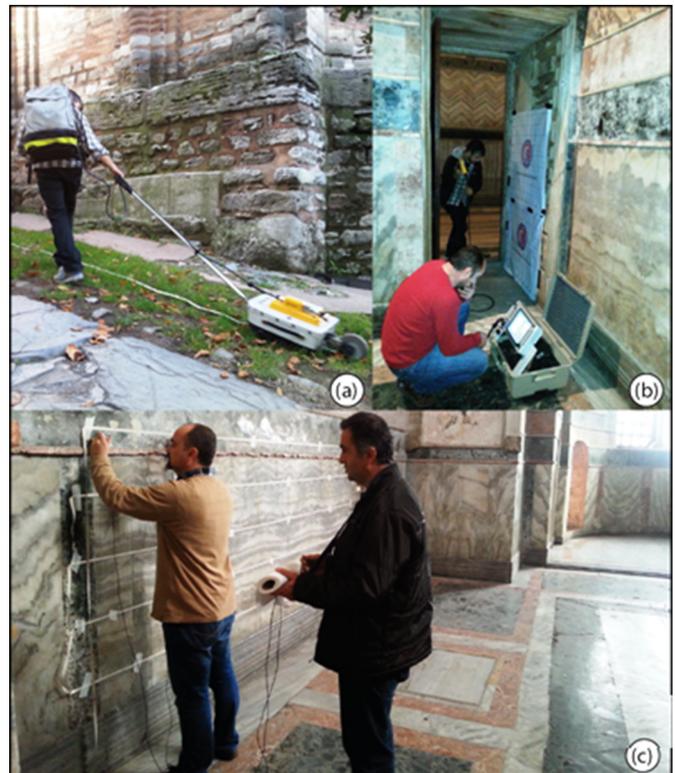
**Fig. 3.** Study photos. (a) GPR ProEx System with 500 MHz antenna. (b) GPR-CX system with 2.3 GHz antenna. (c) UPV measurement.

a structure can be explored and displayed using non-destructive methods (Fig. 3). In-wall imaging of structural walls or structural system elements, as well as the depth of irregularities such as cracks and cavities that can be identified can be illustrated by radar measurements. We also used a 500 MHz shielded GPR system around the museum to determine the environmental effects damaging the building (Fig. 3).

In this study the GPR-CX measurements were conducted by using 2.3 GHz antenna within a grid (10 cm between the profiles in both directions vertical and horizontal) (Fig. 3b). The GPR measurements used 500 MHz shielded antenna with parallel profile lines (Fig. 3a). Both measurement parameters are given in Table 1.

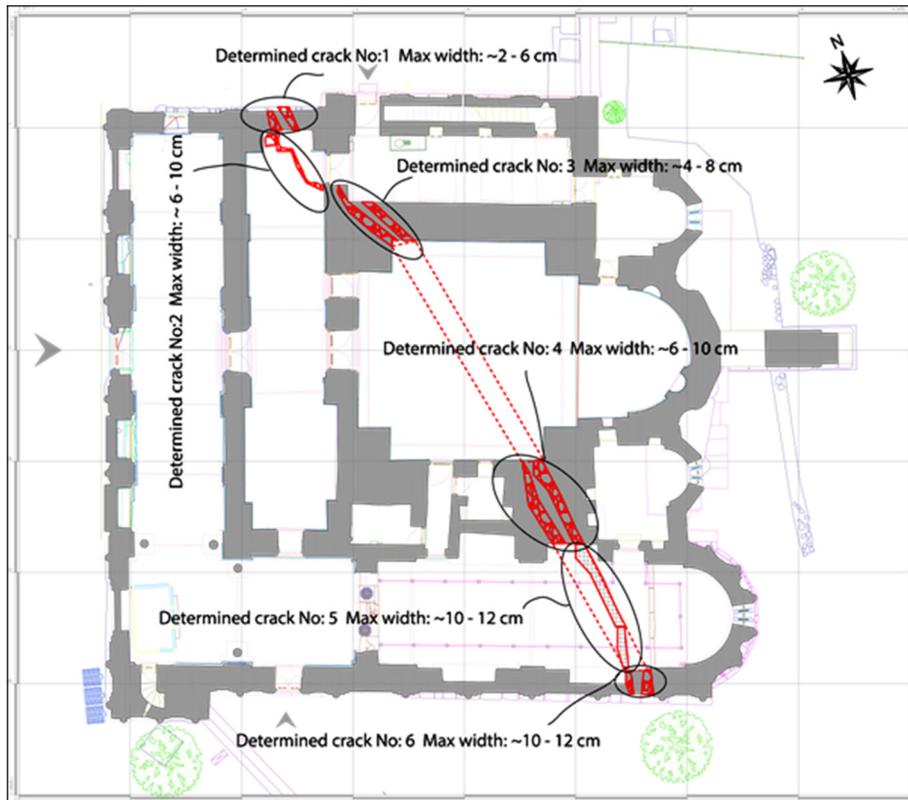
Fig. 14. The top view of the cracks on the plan view and the approximate description of the crack sizes (the broken lines are below the floor and are detected in GPR floor measurements).

It was determined that the main cracks are on an axis based on measurements of high-precision GPR-CX (2.3 GHz) and UPV made on all walls within the building (Fig. 14).

The cracks on this axis were determined in the GPR profiles as having been filled during previous repairs. However, the filling material is different from the building materials (brick, joint, plaster etc.) that constitute the building walls and at the same time the presence of cavity spaces was determined. The cracks found on the axis displaying coquis shown in Fig. 14 are defined in 6 different zones according to their locations and widths. According to this;

- Cracked structure detected in the north external wall, approximate width = ~2--6 cm.
- Cracked structures detected at the base of the internal narthex, nearly maximum width = ~6--10 cm.
- Cracked structure detected in the wall of naos north, nearly maximum width = ~4--8 cm.
- Cracked structure detected in the wall of south naos, approximate maximum width = ~6--10 cm.
- Cracked structure determined on the paraclesion dome, approximate maximum width = ~10--12 cm.
- Cracked structure detected in the south external wall, approximate maximum width = ~10--12 cm.
